## Inspection Report

### Advanced inspections ltd

26 A

Mt Stewart Halcombe Road

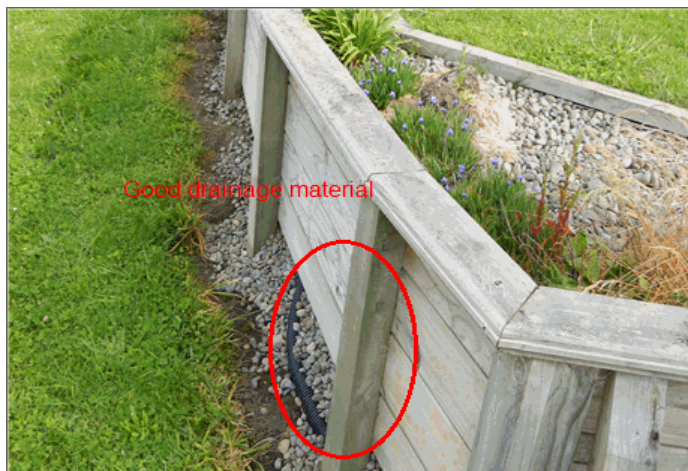
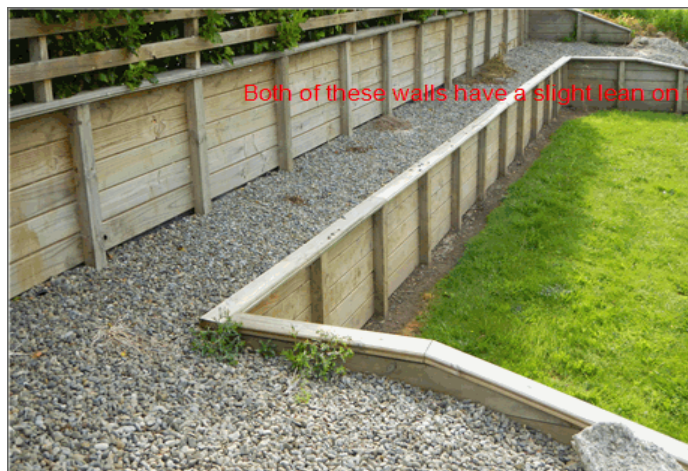
**2) RETAINING WALL  
CONDITION****RM**

All the retaining walls have visible signs of good drainage material behind them. The double wall at the rear of the property appears to have a slight lean on it. This will require monitoring. If it gets worse over time I would recommend a builder assess it.

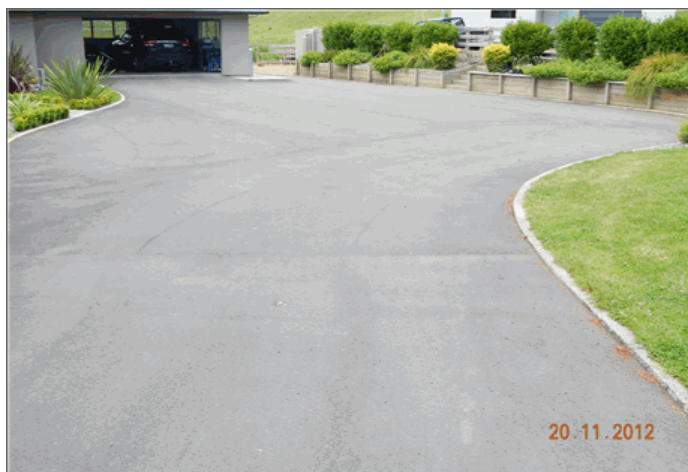
**DRIVEWAY****3) DRIVEWAY CONDITION****OK**

The driveway is a hot-mixed tarsealed driveway. Of the visible areas, the general condition is ACCEPTABLE or in REASONABLE CONDITION for age of dwelling with NO VISIBLE MAJOR DEFECTS.

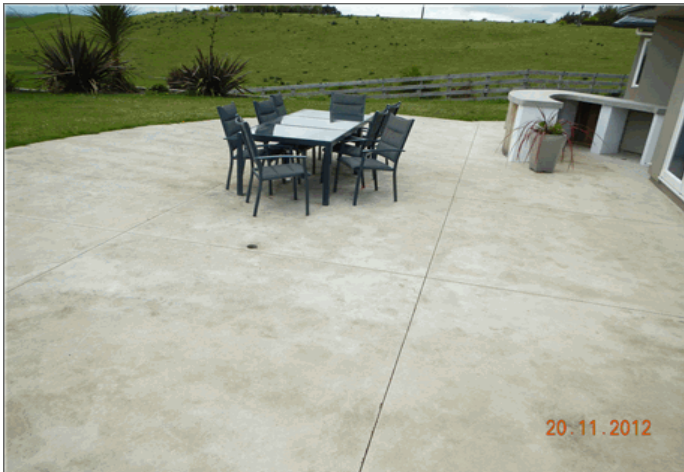
### 4) PATHWAYS CONDITION

Of the visible areas, the general condition is ACCEPTABLE or in REASONABLE CONDITION for age of dwelling with NO VISIBLE MAJOR DEFECTS.

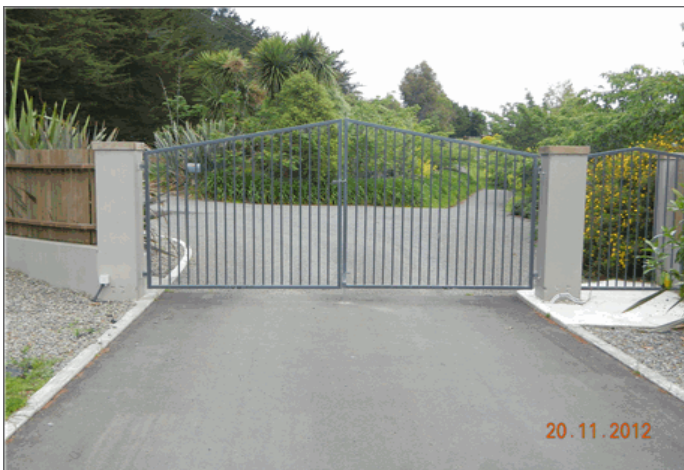
### 6) FENCE CONDITION

Timber post and rail fences with concrete pilers and steel gates. Of the visible areas, the general condition is ACCEPTABLE or in REASONABLE CONDITION for age of dwelling with NO VISIBLE MAJOR DEFECTS.

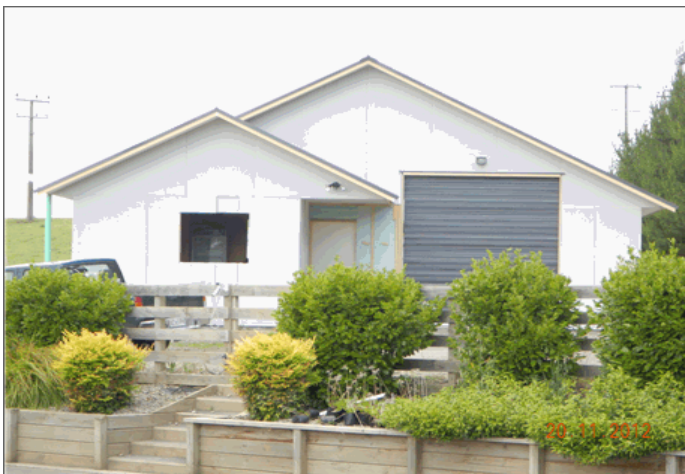
### 10) SHED CONDITION

A new separate shed (large) is still under construction. This still requires finishing, as such this was not inspected.

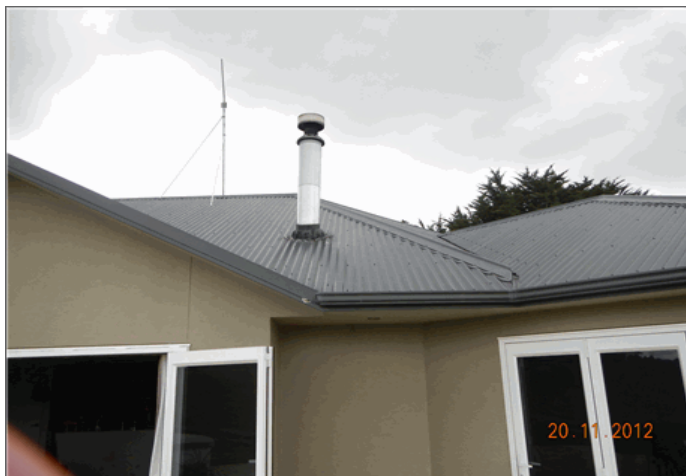
##### 14) CHIMNEYS CONDITION

Of the visible areas, the general condition is ACCEPTABLE or in REASONABLE CONDITION for age of dwelling with NO VISIBLE MAJOR DEFECTS. Steel flue chimney flashing has been installed correctly

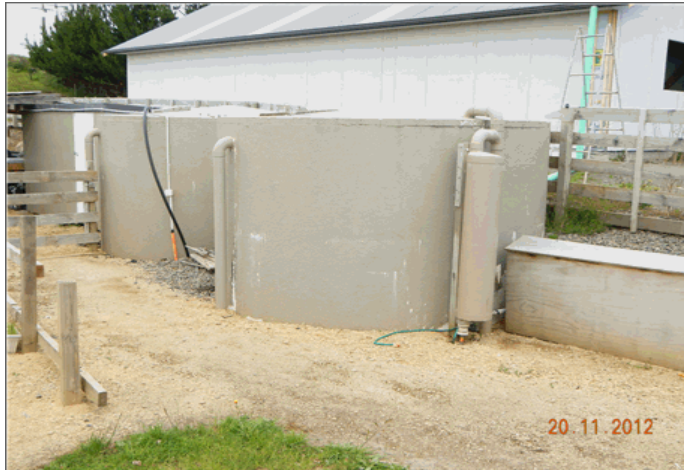
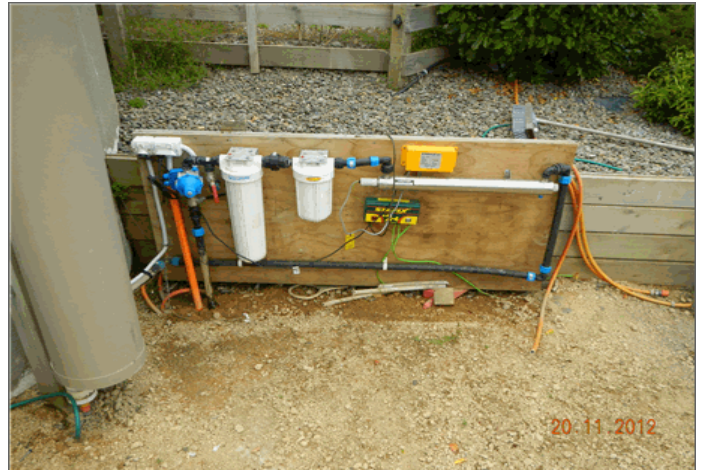
##### 15) Hot Water Unit Findings

This house has 2 concrete water tanks and is running through 2 water filters and then a UV filter. **NO WATER UNIT DEFECTS** Visible.

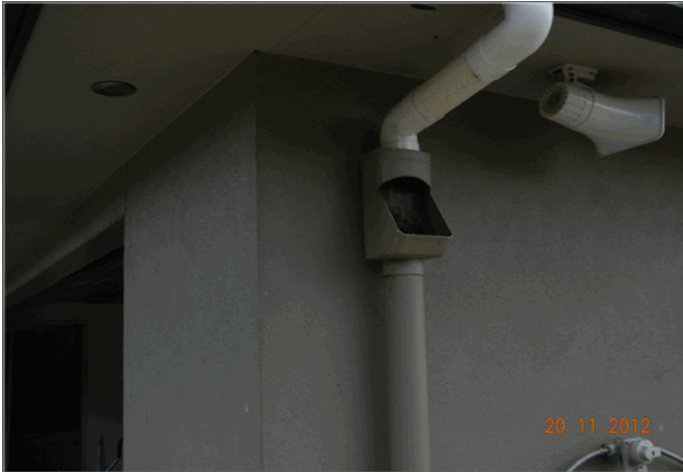
All down Pipes have leaf traps fitted to them. These need to be keep clean.

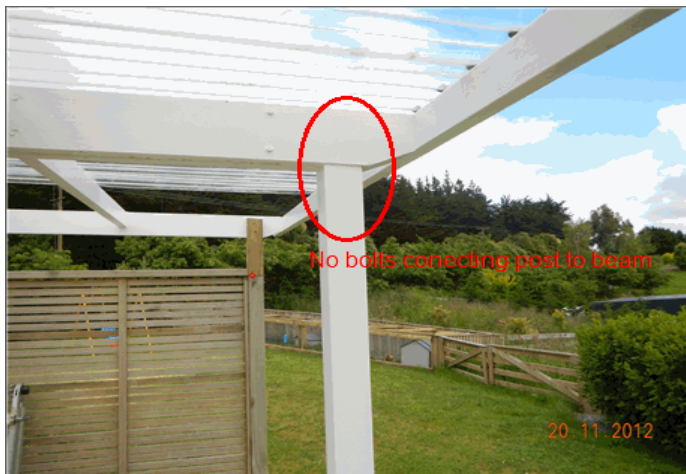
#### 41) PERGOLA POSTS

The bolts are missing that connect the beams to th the post.

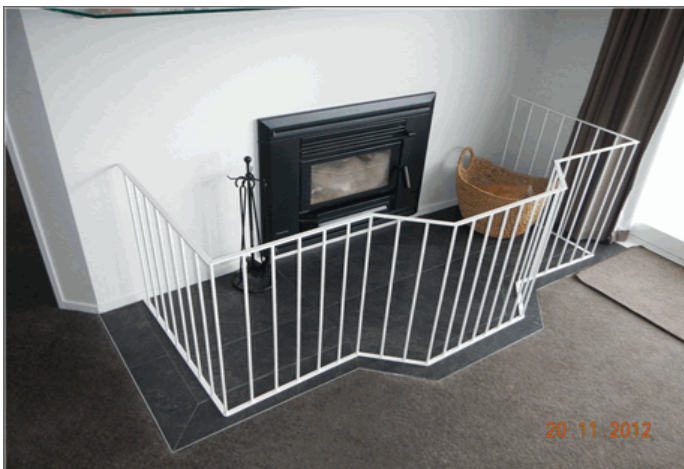
This house has a masport in-built wood burner. This was not tested. I recommend getting the chimney cleaned be for using it and then annually thereafter.

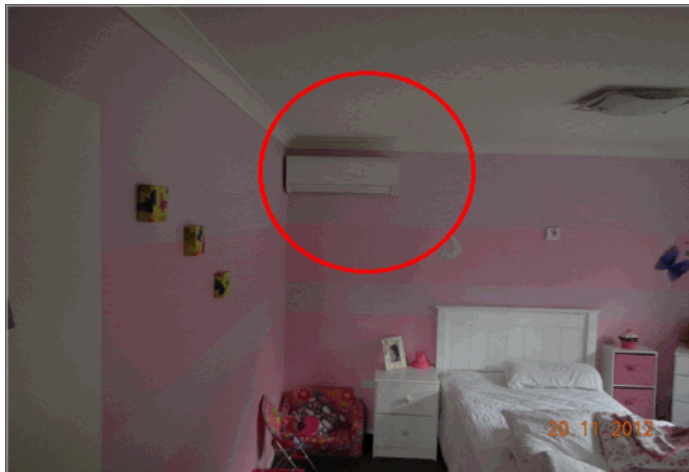
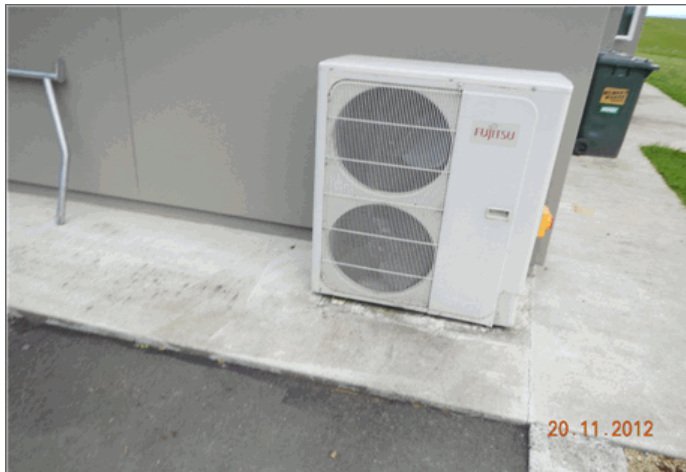
## 45) Heat pump

Ducted heat pump. All vents seem to be in working order. Bedroom 2 has it's own heat pump.

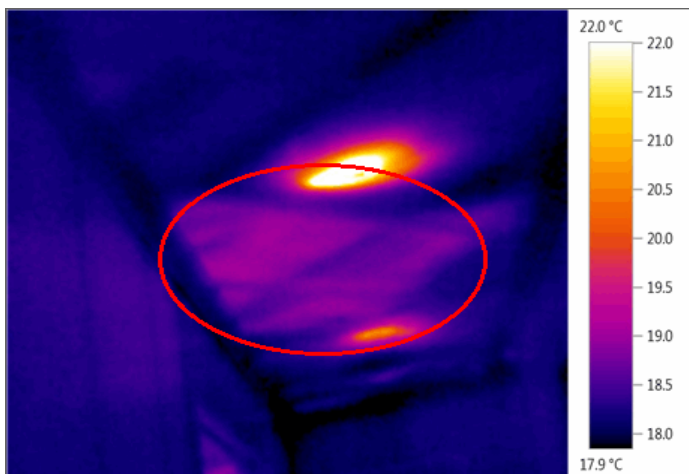
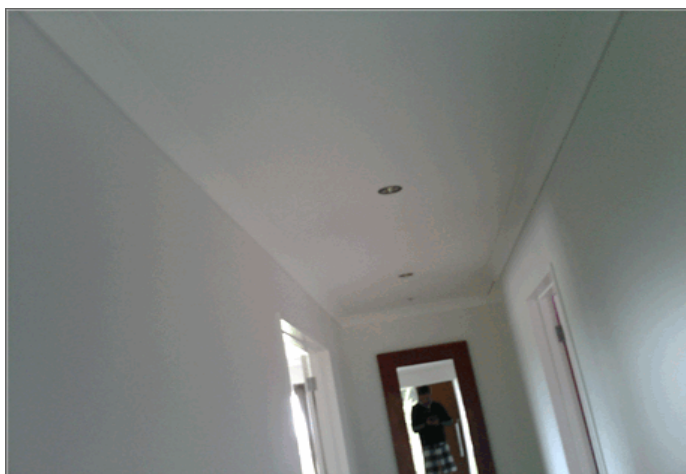
## 48) Ceiling

Of the visible areas, the general condition is ACCEPTABLE or in REASONABLE CONDITION for age of dwelling with NO VISIBLE MAJOR DEFECTS. Thermal images reveal there is missing insulation.

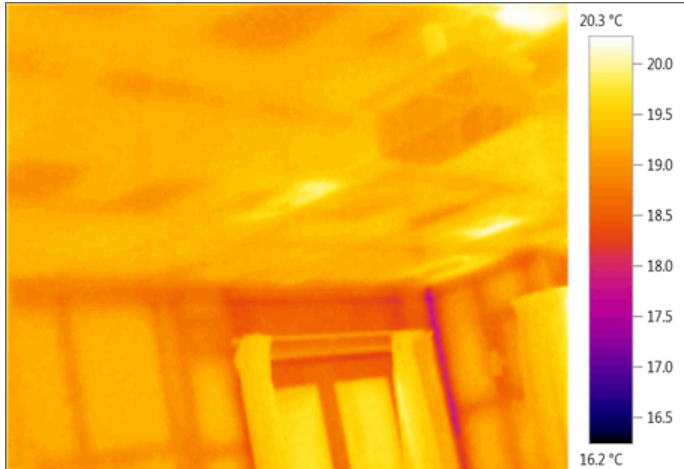
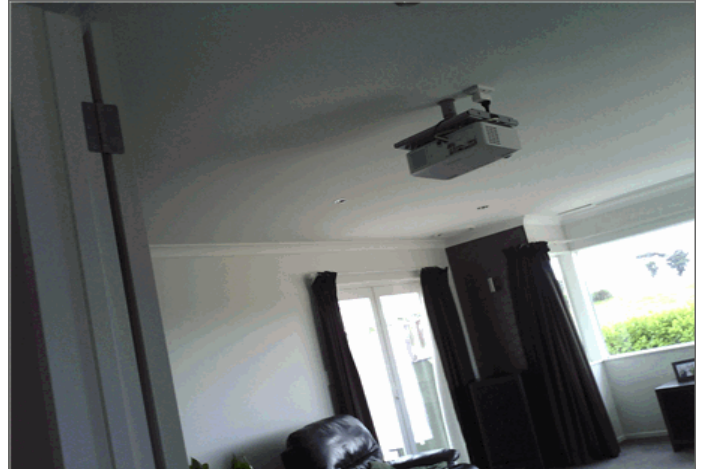
**56) Ceiling**

Thermal images reveal there is no missing insulation.

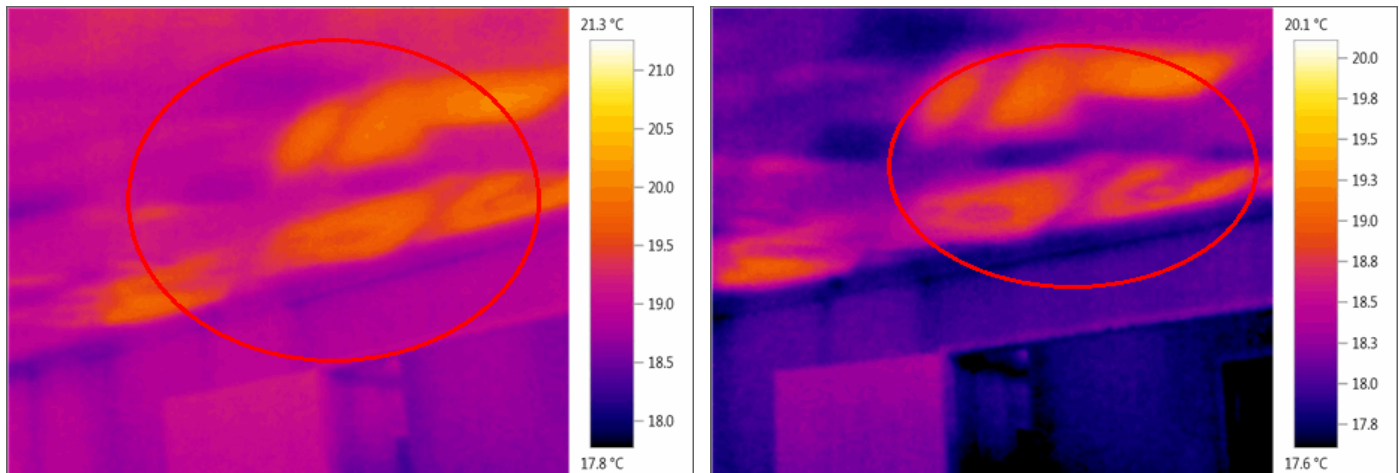
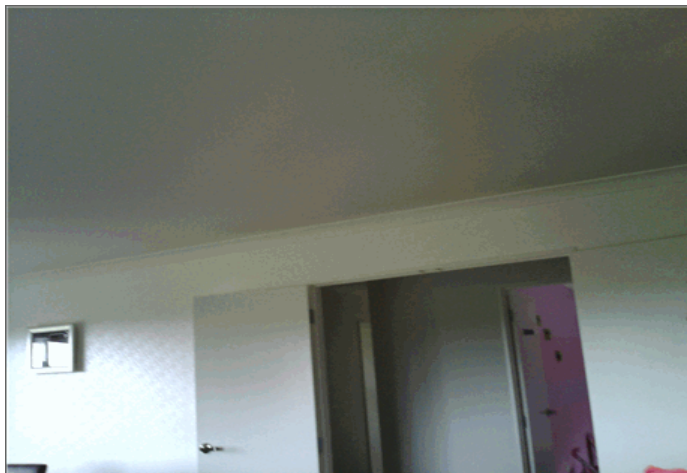
**64) Ceiling**

INTERIORS	64	Thermal images reveal there is missing insulation.
INTERIORS	80	Of the visible areas, the general condition is ACCEPTABLE or in REASONABLE CONDITION for age of dwelling with NO VISIBLE MAJOR DEFECTS. Thermal images reveal there is missing insulation.

Thermal images reveal there is missing insulation.

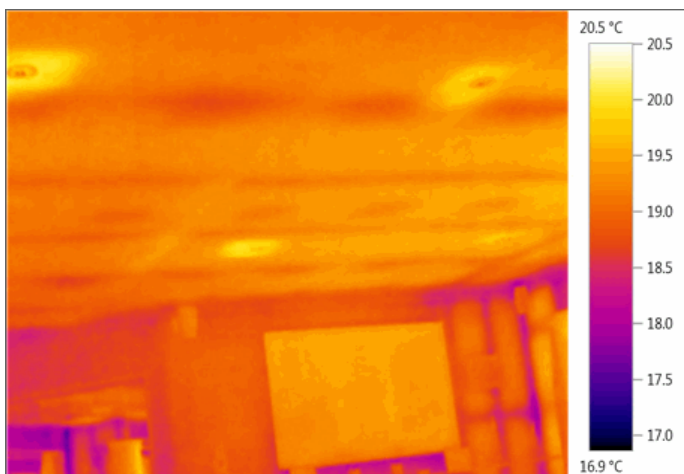
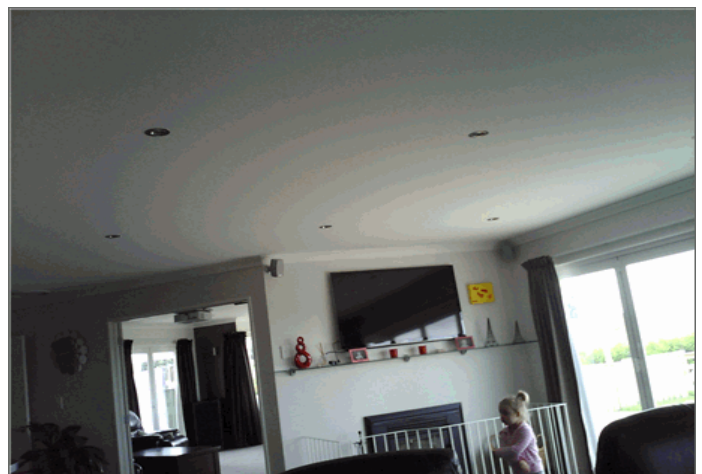
**72) Ceiling**

Thermal images reveal there is no missing insulation. Darker squares are back blocks on gib ceilings this is this good practice

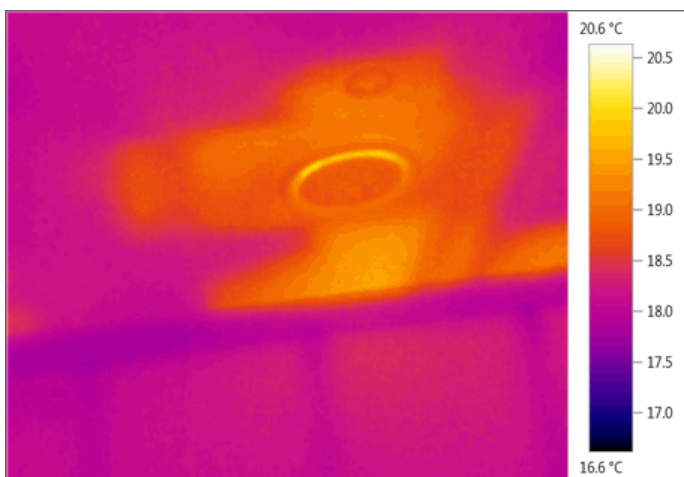
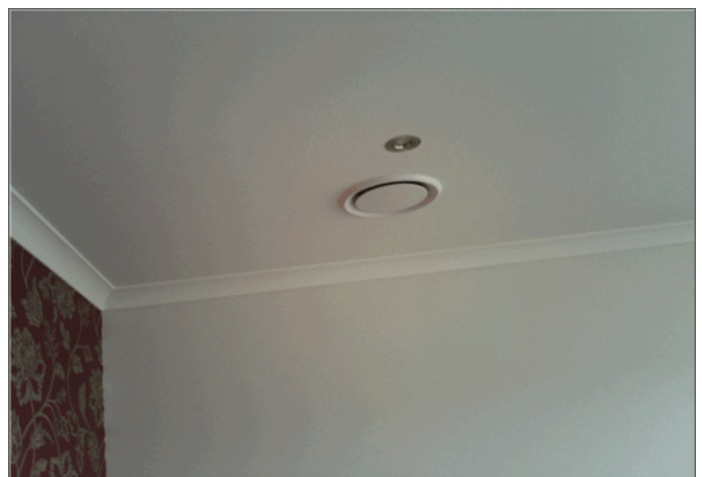
**80) Ceiling**

Of the visible areas, the general condition is ACCEPTABLE or in REASONABLE CONDITION for age of dwelling with NO VISIBLE MAJOR DEFECTS. Thermal images reveal there is missing insulation.

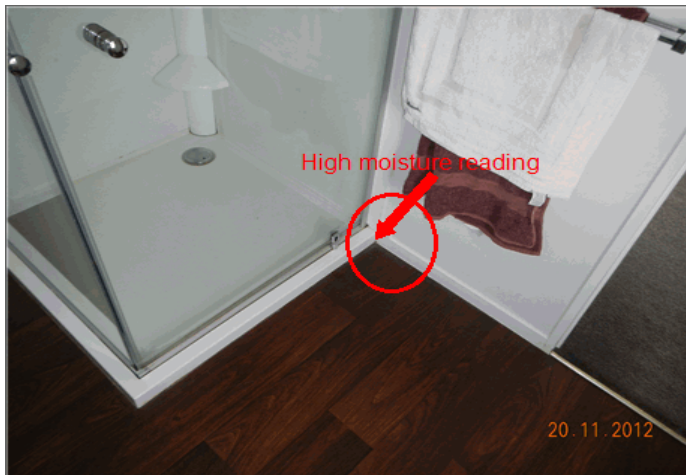
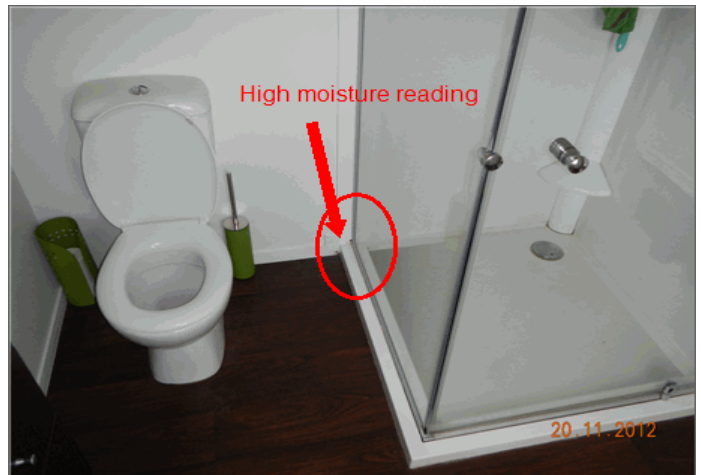
Of the visible areas, the general condition is **ACCEPTABLE** or in **REASONABLE CONDITION** for age of dwelling with **NO VISIBLE MAJOR DEFECTS**. However the moisture meter test gave a high reading in the bottom corners of the shower on the outside of the glass walls.
