## Inspection Report

### Advanced inspections ltd

26 A

Mt Stewart Halcombe Road

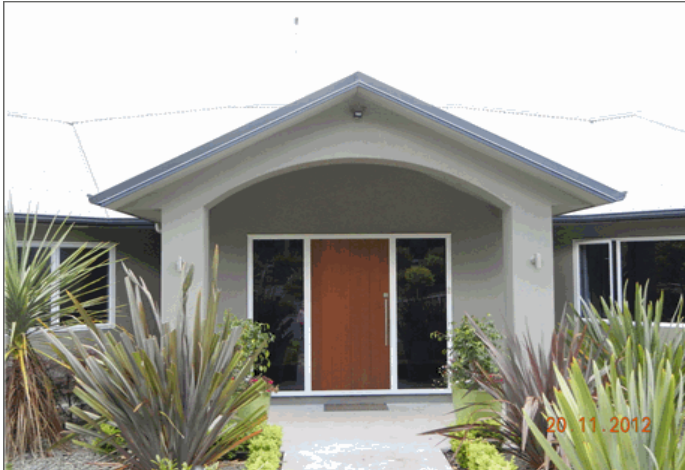
### 7) COLUMN or POST CONDITION

Of the visible areas, the general condition is ACCEPTABLE or in REASONABLE CONDITION for age of dwelling with NO VISIBLE MAJOR DEFECTS.

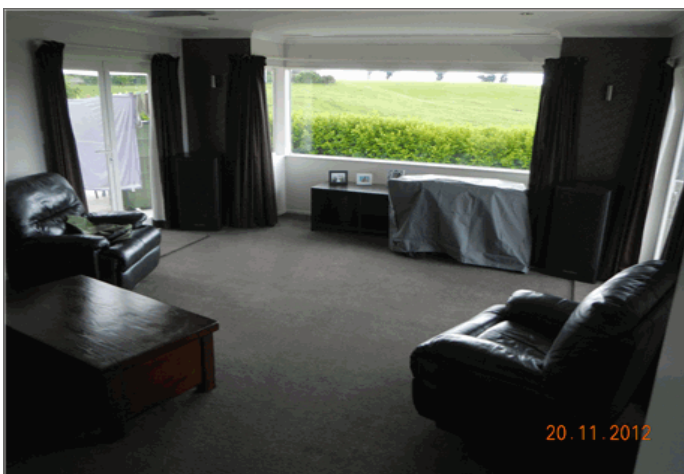
**Lounge Room****54) Overall Condition****OK**

Of areas visible, there was **NO VISIBLE EVIDENCE** of any **MAJOR STRUCTURAL DEFECTS, SAFETY HAZARDS** or **MAJOR DEFECTS** likely to cause further deterioration of the dwelling.

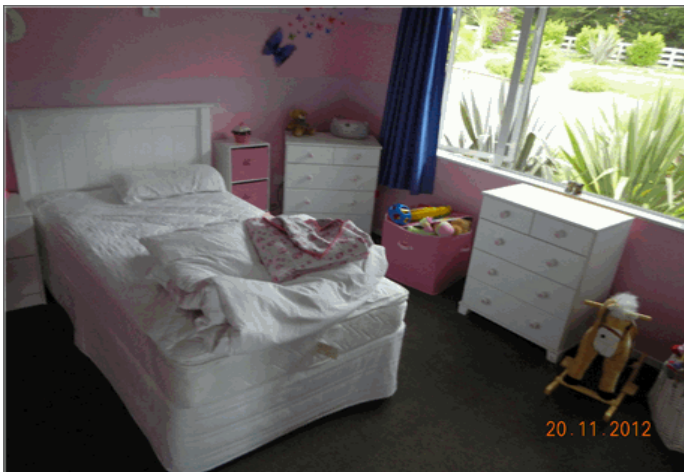
**Bedroom 2****86) Overall Condition****OK**

Of areas visible, there was **NO VISIBLE EVIDENCE** of any **MAJOR STRUCTURAL DEFECTS, SAFETY HAZARDS or MAJOR DEFECTS** likely to cause further deterioration of the dwelling. Please read below for details.

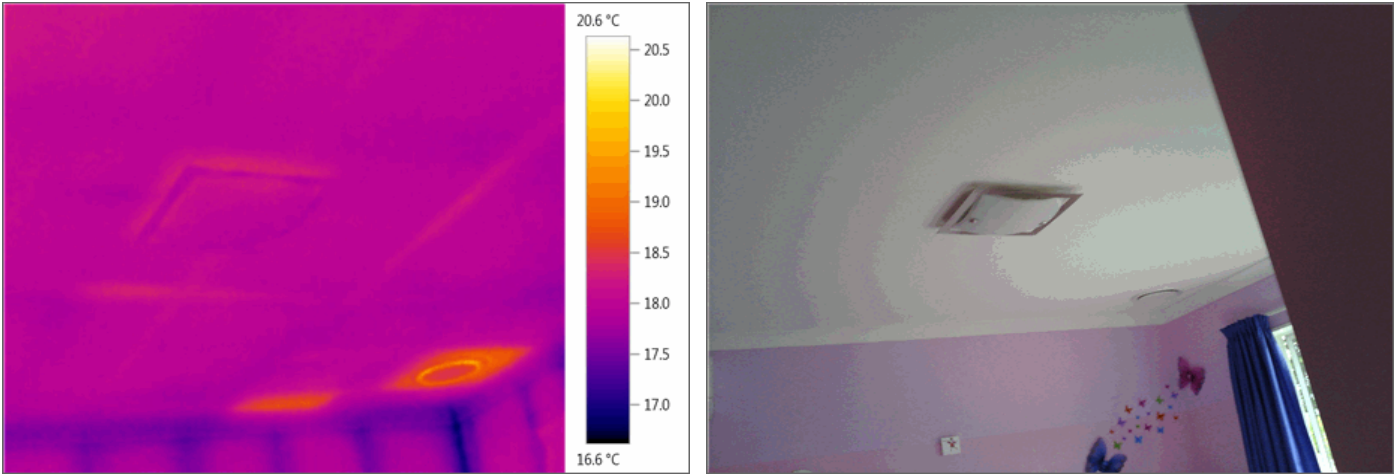
- 89) Walls

Of the visible areas, the general condition is ACCEPTABLE or in REASONABLE CONDITION for age of dwelling with NO VISIBLE MAJOR DEFECTS. Thermal images reveal there is no missing insulation.
- 90) Windows

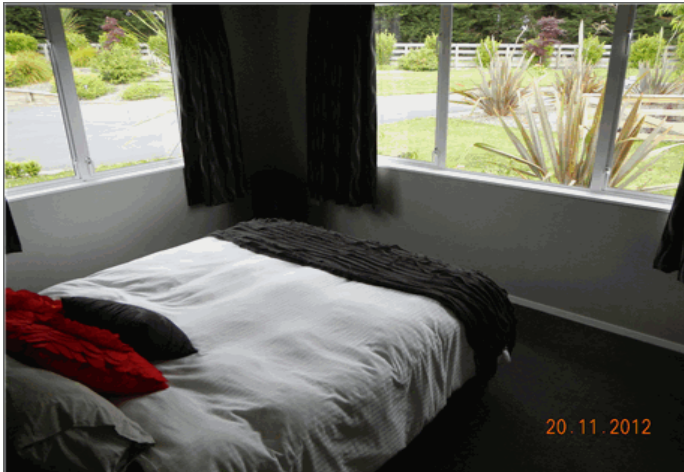
Of areas visible, there was **NO VISIBLE EVIDENCE** of any **MAJOR STRUCTURAL DEFECTS, SAFETY HAZARDS or MAJOR DEFECTS** likely to cause further deterioration of the dwelling.

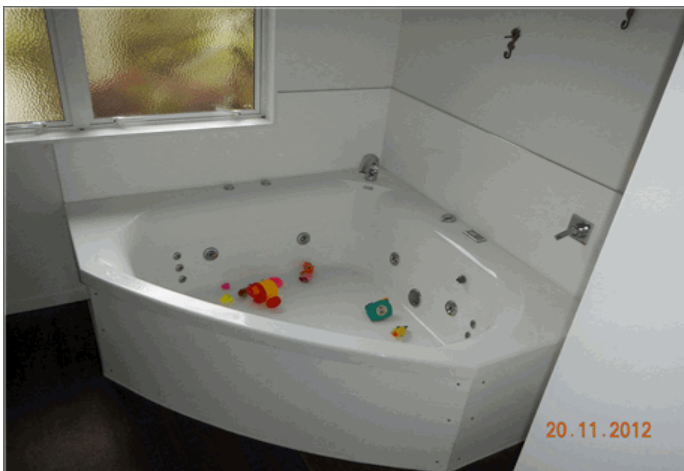
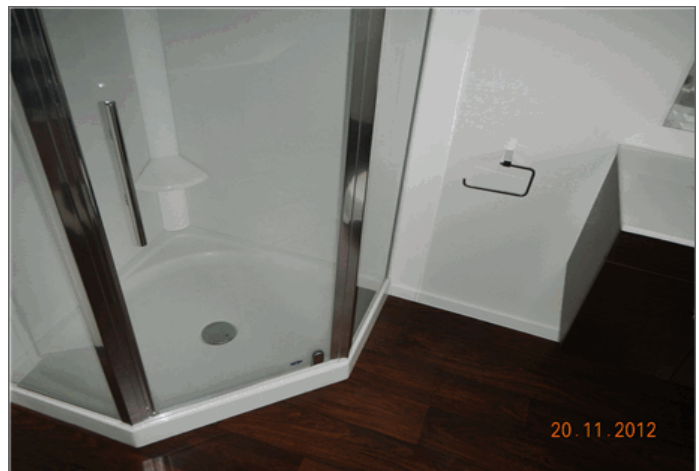
110) Overall Condition

An exhaust fan is **PRESENT AND OPERABLE** in the bathroom - regular cleaning advised.

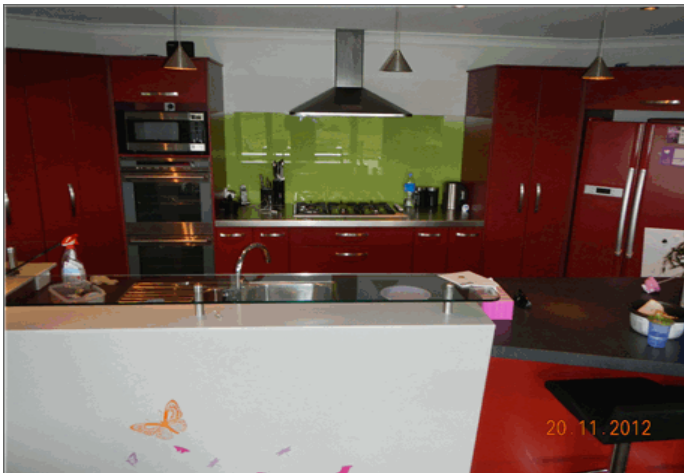
Of areas visible, there was **NO VISIBLE EVIDENCE** of any **MAJOR STRUCTURAL DEFECTS, SAFETY HAZARDS or MAJOR DEFECTS** likely to cause further deterioration of the dwelling.

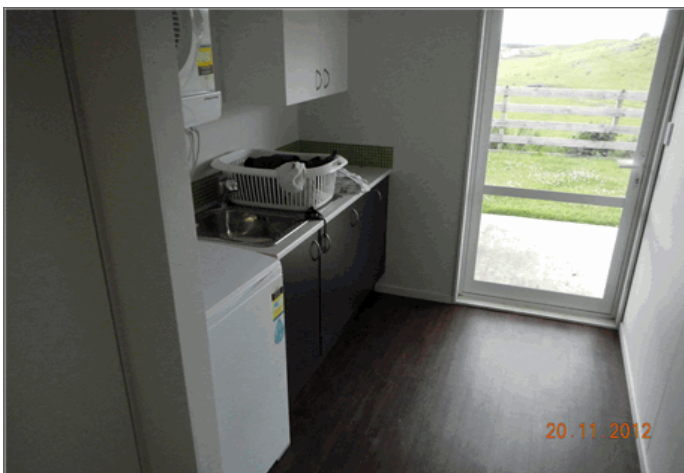
Of areas visible, there was **NO VISIBLE EVIDENCE** of any **MAJOR STRUCTURAL DEFECTS, SAFETY HAZARDS or MAJOR DEFECTS** likely to cause further deterioration of the dwelling.
